Endovascular Management following Unintentional Subclavian Artery Injury during Central Venous Catheter Placement

David T McGreevy MD

Department of Cardiothoracic and Vascular Surgery, Faculty of Medicine and Health, Örebro University Hospital and Örebro University, Örebro, Sweden

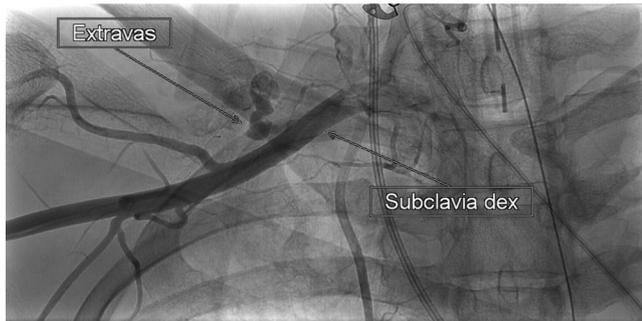
Figure 1 Angiography showing extravasation from the right subclavian artery after CVC placement.

A previously healthy 38-year-old male was monitored and managed on the intensive care unit for bilateral pneumonia of unknown etiology. When the patients condition worsened, he was put under general anesthesia, intubated and, on day 6 a triple lumen CVC was inserted by an experienced intensive care physician into the right internal jugular vein using an ultrasound-guided supraclavicular approach. Subsequently, because of suspected pulmonary embolism, a computer tomography (CT) was performed which showed a 5 cm supraclavicular hematoma with ongoing extravasation from the right subclavian artery. The patient was hemodynamically stable and was taken to the hybrid operating room where the on-call vascular surgeon placed a 4 Fr introducer retrograde in the right brachial artery. The angiography showed continued extravasation (Figure 1). The introducer was upgraded to a 6 Fr and a 6 × 50 mm² Viabahn

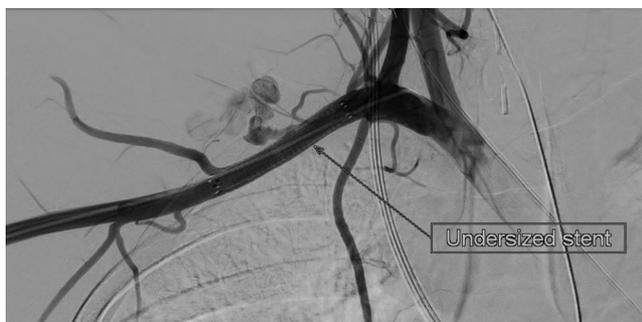
Figure 2 Undersized stent graft with continued extravasation from the right subclavian artery.

stent graft (W.L. Gore & Associates, Flagstaff, Arizona) was placed in the right subclavian artery, distally to the right vertebral artery, covering the vessel injury. The stent graft was, however, undersized resulting in continued extravasation (Figure 2). Additionally, the undersized stent graft migrated distally in the subclavian artery and after unsuccessful attempts were made to reposition the migrated stent graft the decision was made to puncture the right common femoral artery and a 6 Fr introducer was placed retrograde (Figure 3). An 8 × 50 mm² Viabahn stent graft was successfully positioned in the right subclavian artery, distally to the right vertebral artery, covering the vessel injury and discontinuing the extravasation (Figure 4). After the procedure, both radial and ulnar pulsations could be heard using doppler.

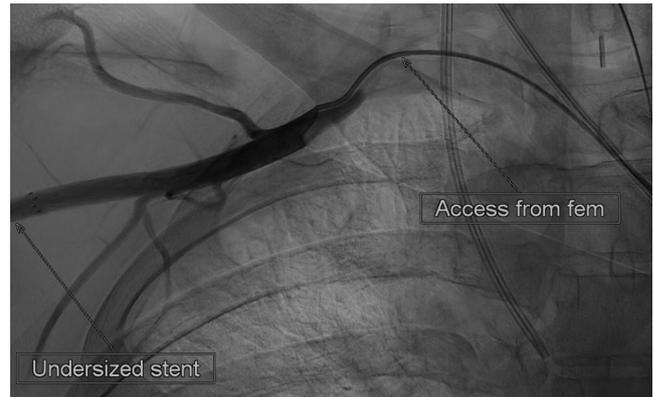
Figure 3 Angiography via right femoral access showing distal migration of undersized stent graft in the right subclavian artery.

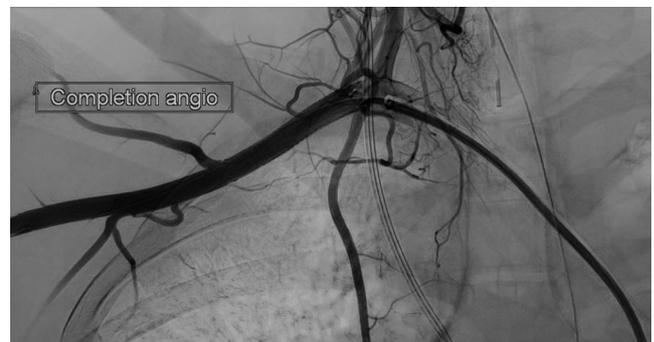
Figure 4 Completion angiography after placement of a correctly sized stent graft in the right subclavian artery showing no extravasation.
